## Control of Highway Runoff at Bridge Structures

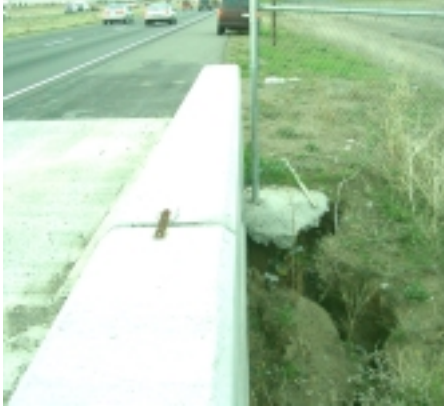
Unless addressed appropriately in the project design phase, bridge railings can concentrate highway runoff, which is often allowed to flow in an uncontrolled form down adjacent embankment slopes.

*Scour around bridge railing*

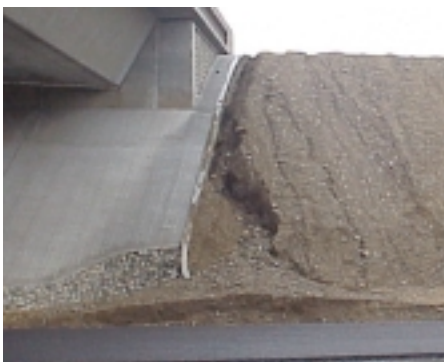
The concentrated flow can lead to localized erosion, which may affect the stability of bridge abutments or other structures.

*Erosion adjacent to bridge abutment*

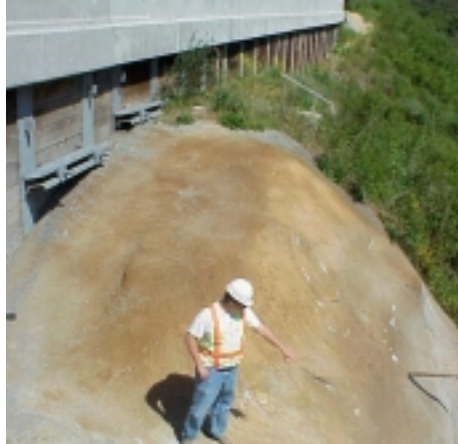
construction. At a bridge railing location where highway runoff had not been adequately controlled, runoff was unintentionally focused down a steep embankment that had no drainage control features. Consequently, substantial erosion occurred. Prior to project construction, the embankment had not been subject to attack by concentrated flows.

*Slope replacement due to runoff damage*

The resulting embankment erosion threatened the stability of the roadway and bridge abutment. The embankment had to be rebuilt and protected, adding millions of dollars to the project cost.

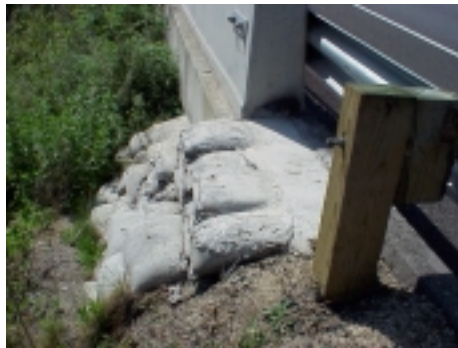
*Improper treatment using concrete sacks*

In the photo above, concrete sacks have been used to rebuild and protect a slope that had experienced localized erosion. This technique may temporarily halt further progression of the erosion, but its long-term effectiveness and stability is not

assured. These impromptu, short-term solutions can be undermined in subsequent storm events and may require excessive future maintenance and repair efforts.

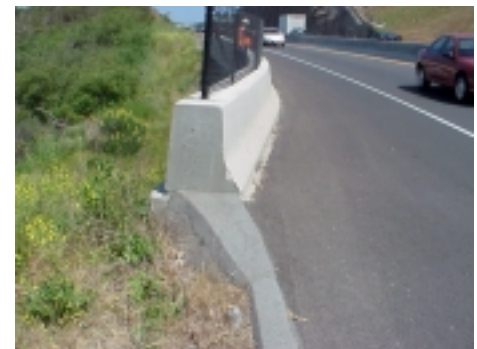
*Proper treatment using an asphalt dike*

Asphalt dikes may be used to control runoff within the shoulder limits, and to guide it to a drainage feature. Alternatively, down drains may be installed at the location of the railing terminus, to collect and transport roadway runoff down the embankment in a controlled manner.
